Manhole Inspection Summary

Manhole # S01UU1018MH

Insp Date: **8/11/06 8:40 AM**

Location Address: **6103 Gist Ave**

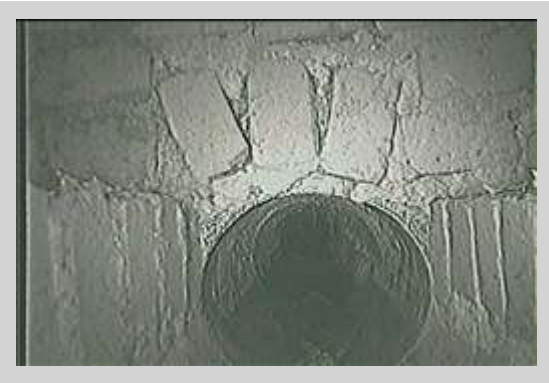
8 in. Circular Gravity Sewer Pipe Out @ 12 O'Clock

Invert Depth: **7.54** (ft.) Flow Characteristics: **Slow**

Infiltration: **None** Pipe Seal Cond: **Sound**

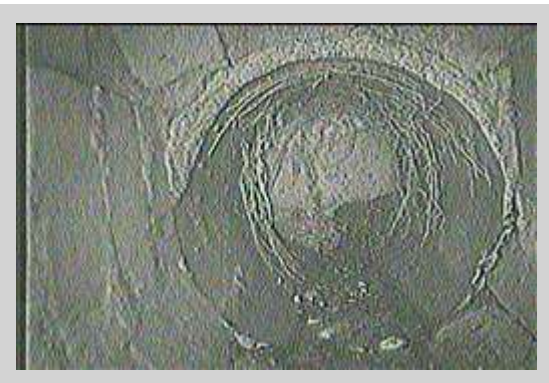
8 in. Circular Gravity Sewer Pipe In @ 6 O'Clock

Invert Depth: **7.34** (ft.) Flow Characteristics: **None**

Infiltration: **None** Pipe Seal Cond: **Roots**

Connects To: **Stub connection / abandoned**

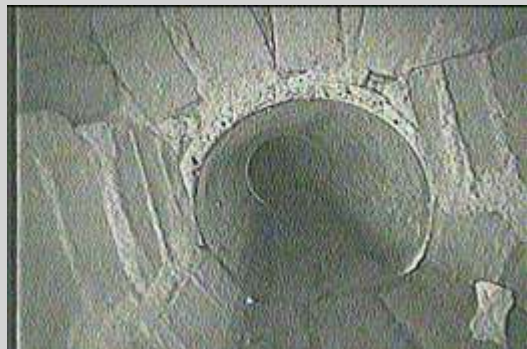
Pipe In @ 8 O'Clock

Infiltration: **None**
